WTCI-344-P

Port Authority of N.Y and N.J.
Litigation Sampling Program

Sample Area Data Sheet

Facility: World Trade Center Building: Tower 1

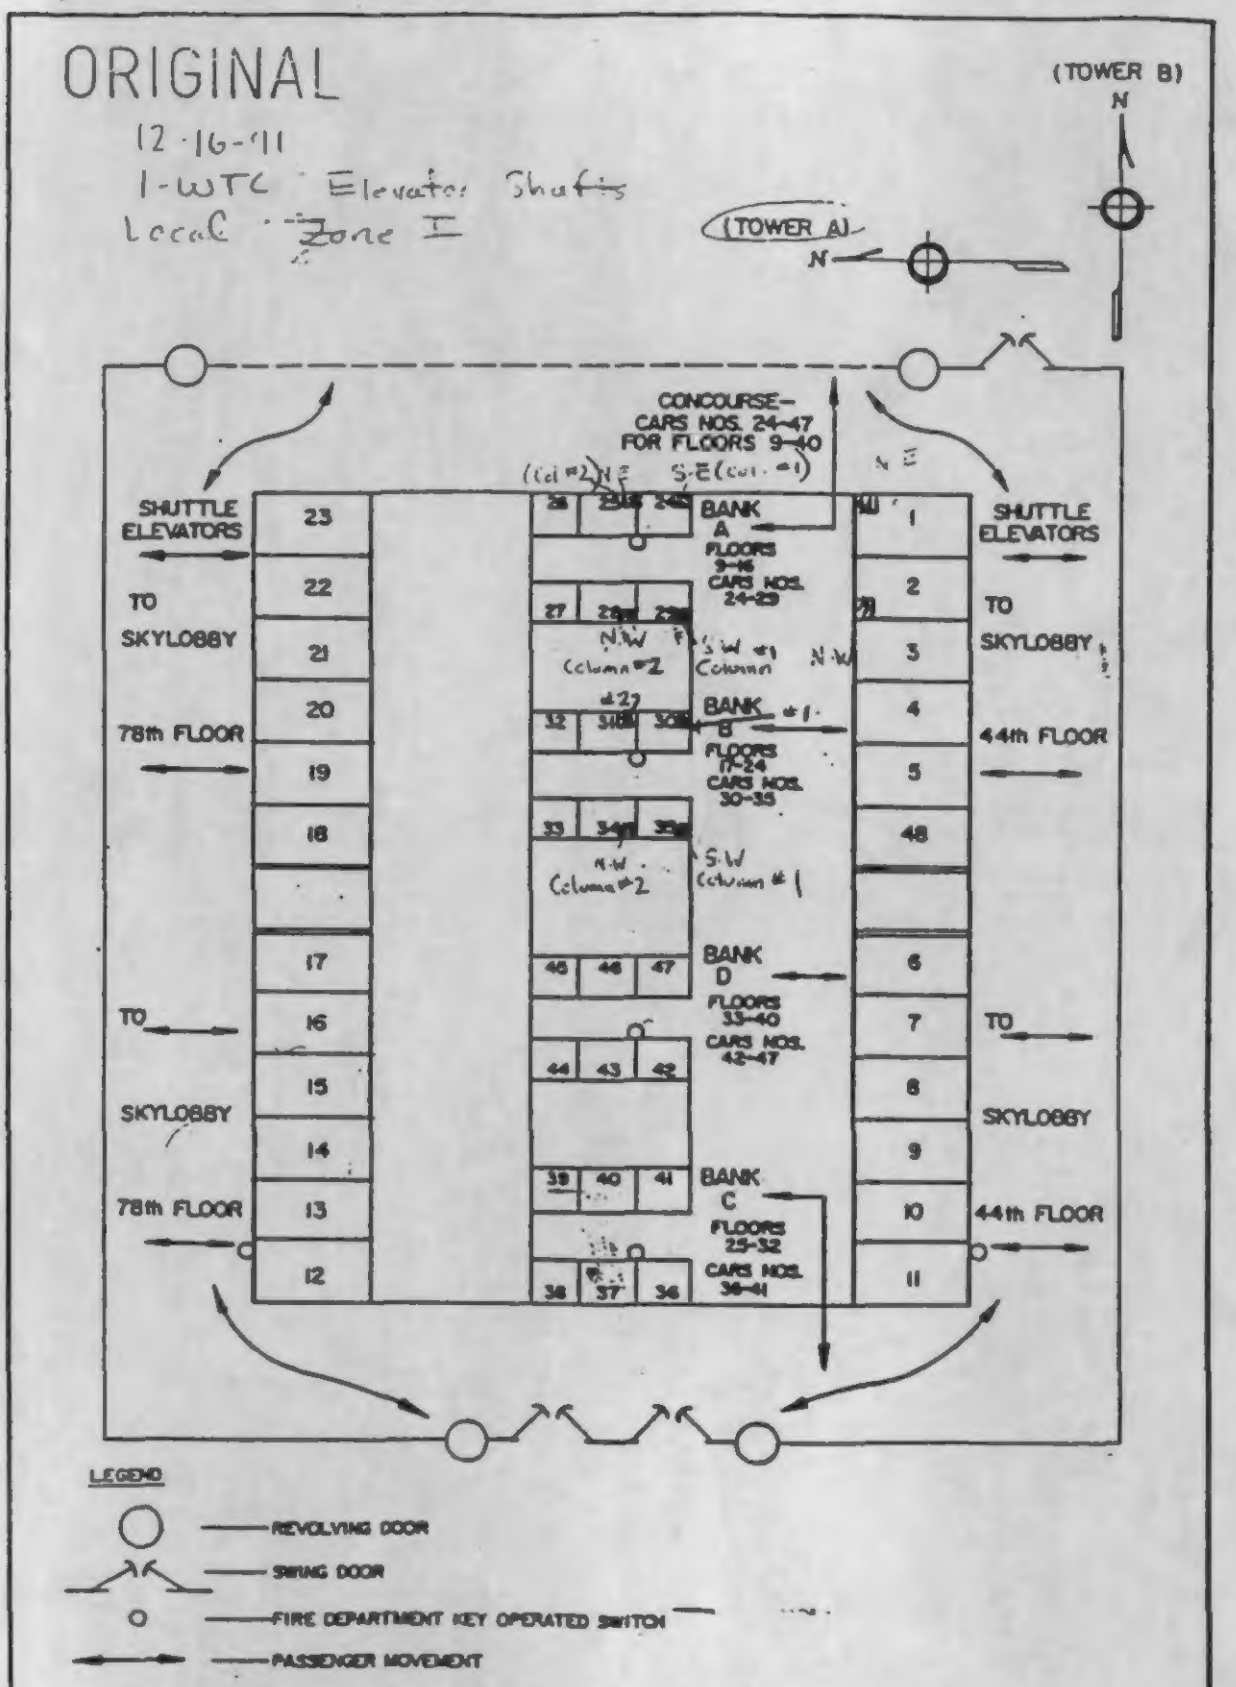
SAMPLE NUMBER	DESCRIPTION OF SAMPLING LOCATION
LL-752-WTC	Spray-on fireproofing and hard coat encapsulant collected From column #1 at the 15th floor. (Elevator Shaft - Pc-24,25,
LL-753-WTC	Spray-on Fireproofing and hard coat encapsulant collected fro Column #2 at the 2nd floor (Elevator Shaft Pc-24,25,26
LL-754-WTC	Spray-on Fireproofing and hard coat encapsulant collected from column #1 at the 15th floor. (Elevator Shaft Pc-27,28,
LL-755-WTC	Spray-on fireproofing and hard coat encapsulant collected from column #2 at the 2nd floor (Elevator Shaft Pc 27,28,29
LL-756-WTC	Spray-on fireproofing and hard coat encapsulant collected from Column #1 at the @23rd floor. (Elevator Shaft Pc-30,31,
LL-757-WTC	Spray-on fireproofing and hard coat encapsulant collected fr Column #2 at the 2nd floor. (Elevator Shaft Pc-30,31,32
LL-758-WTC	Spray-on fireproofing and hard coat encapsulant collected from Column #1 at the 23rd floor (Elevator Shaft Pc-33,34

759-WTC	Spray-on fireproofing and hard coat encapsulant collected from Column #2 at the 2nd Floor. (Elevator Shaft Pc 33,34,35

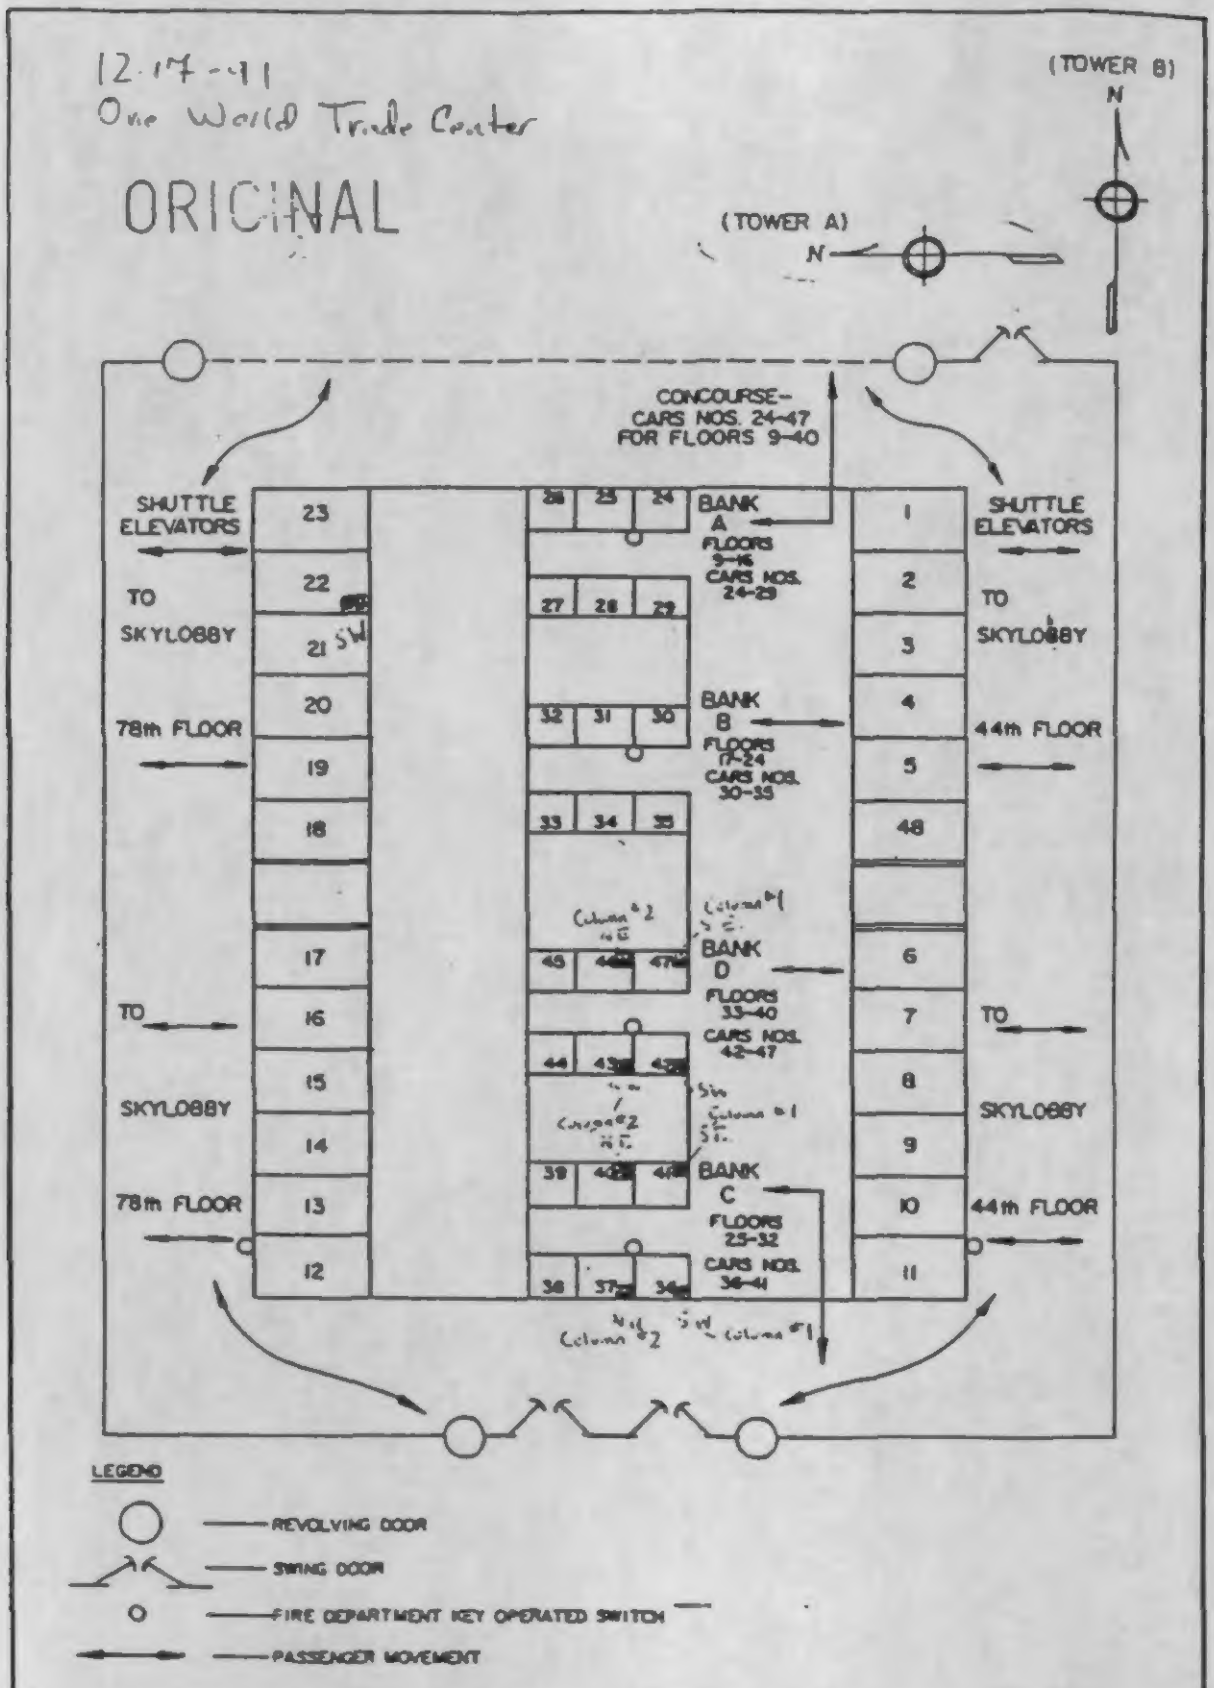
LE NUMBER	DESCRIPTION OF SAMPLING LOCATION
L-770-WTC	Spray-on fireproofing and hard coat encapsulant Sampled at the 76th floor off of car #22 from the column next to the entrance.

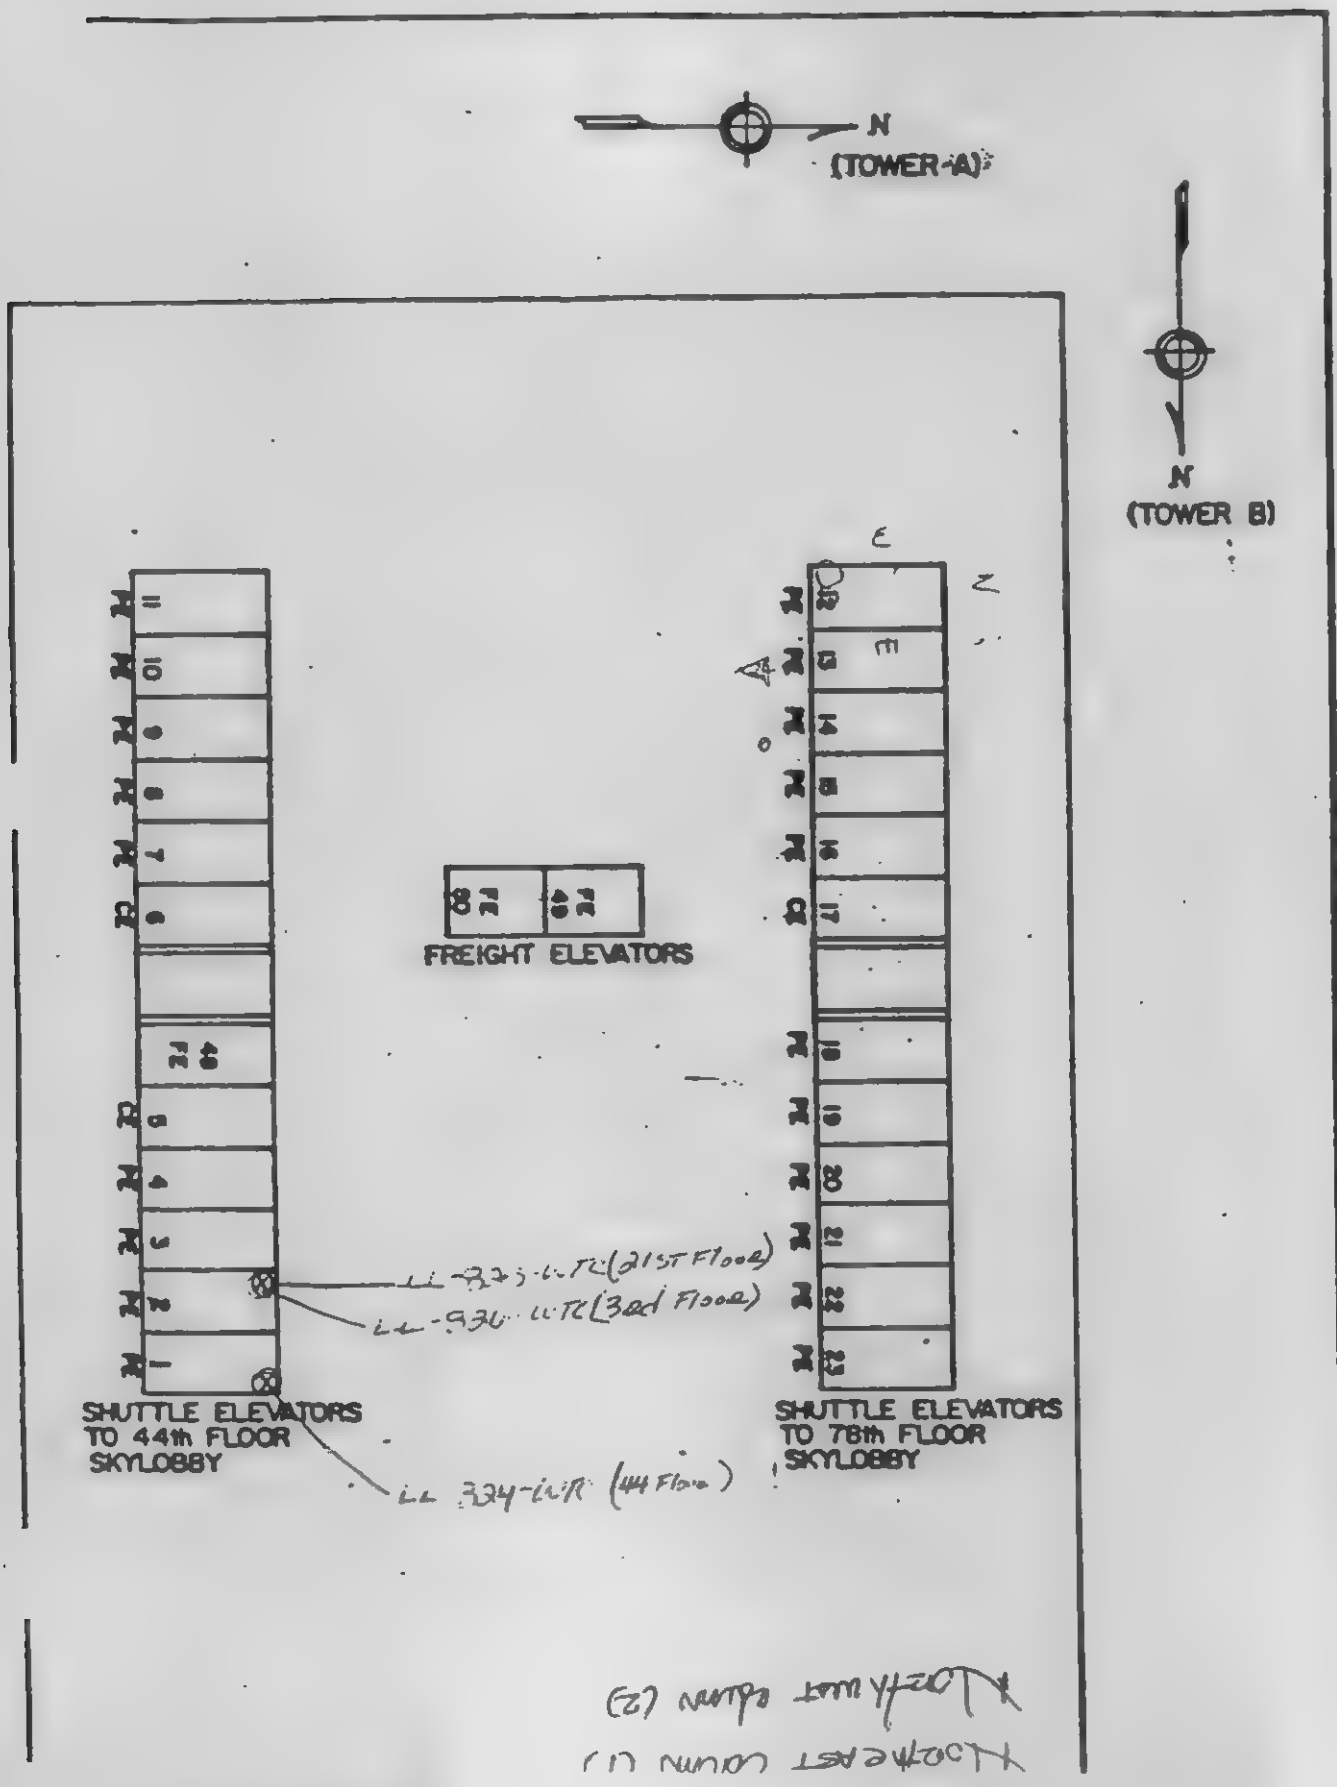
PLE NUMBER	DESCRIPTION OF SAMPLING LOCATION
384-WTC	Spray on fireproofing & Hard Encapsulant Sampled from (36"x12") Column. Sample collected from 44th Floor, Column No. 1, Core-1
L-825-WTC	Spray on fireproofing & Hard Encapsulant Sampled from (36"x12") Column Sample collected from 21st Floor, Column No 2, Core-2
LL-826-WTC	Spray on fireproofing & Hard Encapsulant Sample from (36"x12") Column. Sample collected from 3rd Floor, Column No 2, Core-2.

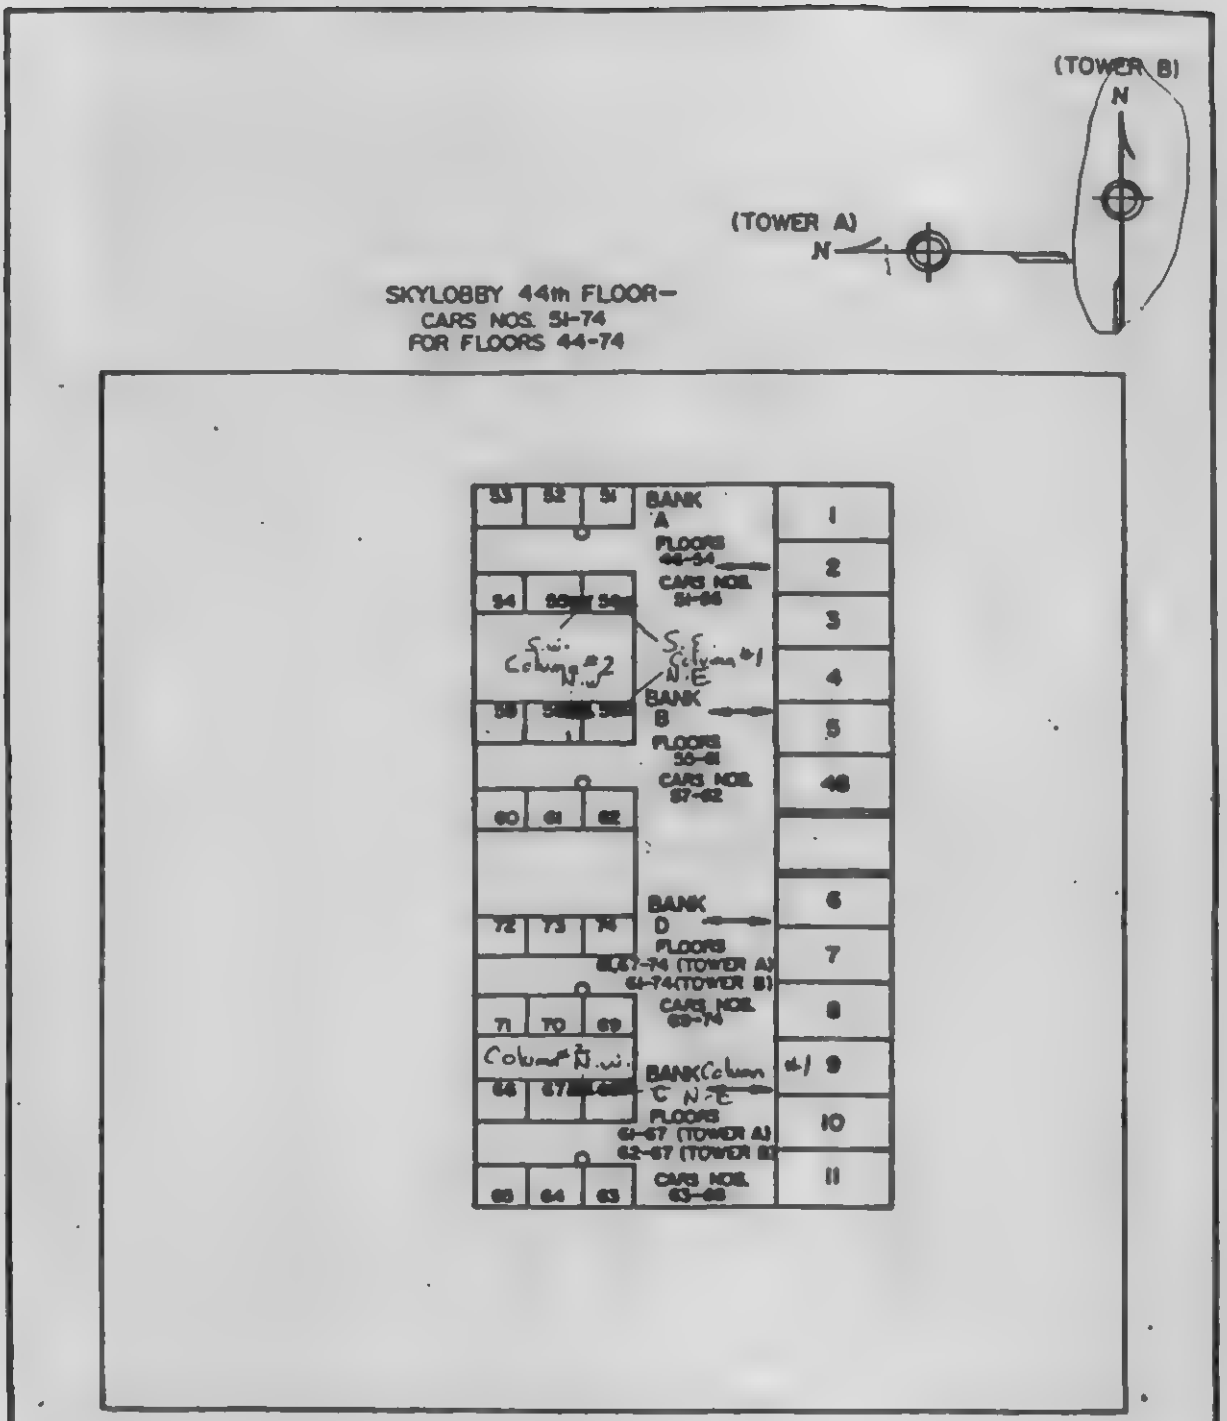
LE NUMBER	DESCRIPTION OF SAMPLING LOCATION
LL-831-WTC	Spray-on fire proofing & Encapsulant mat'l Sampled from a (52") I-colum Sample collected from the 54th floor, colum no*2, CAR pe-56
LL-832-WTC	Spray-on fireproofing & Encapsulant mat'l Sampled from a (52") I-colum Sample collected from the 45th floor, colum no*1, CAR pe-56
